TOWN OF DRACUT Beaver Brook Farm

**Existing Conditions Report -
Two Outbuildings**

September 30, 2021

Existing Conditions Report
TWO EXISTING BARNS
Beaver Brook Farm
Dracut, MA

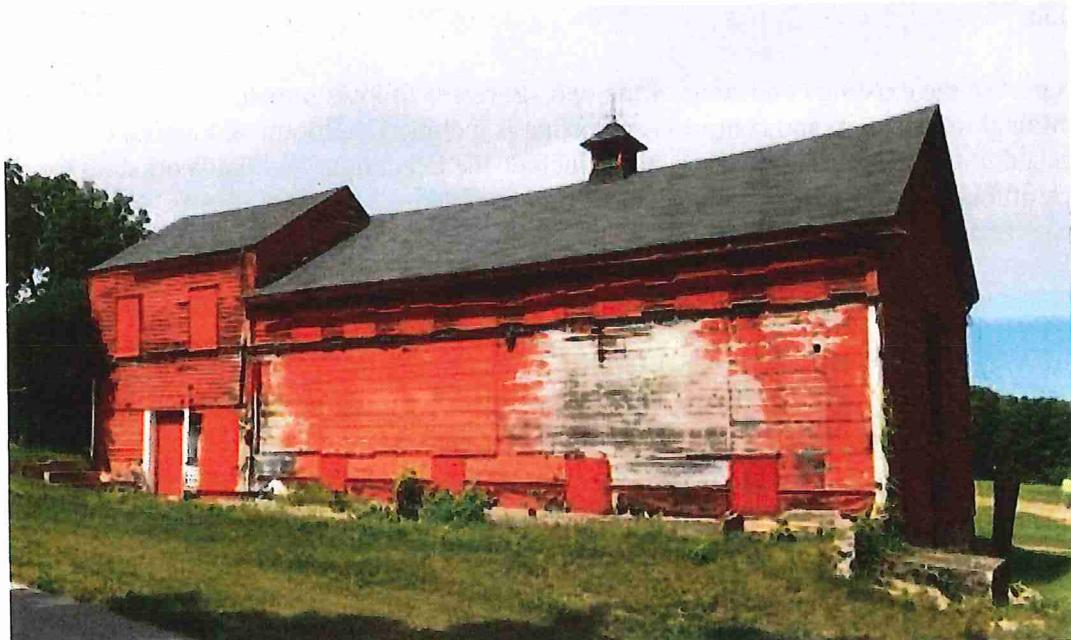
Figure 3 - Seedhouse Building, note horizontal dark line where greenhouse framing used to attach

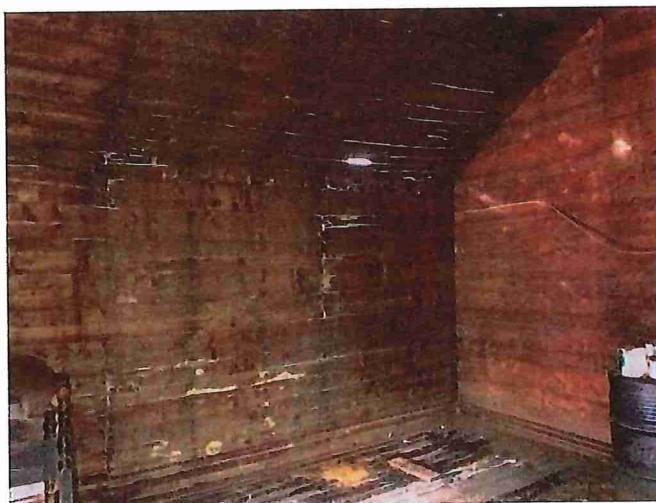
Figure 8 - Northeast corner of the Storage Barn wall and floor showing water damage

The northeast corner of the Storage Barn is missing a large section of the overhanging eaves, and a section of the roof immediately adjacent. The sections of the roof framing and sheathing that is

exposed to the exterior show signs of substantial degradation. Water is infiltrating in this area and signs of water damage are evident at the interior and exterior finishes of the wall below down to and including the sill, as well as the floor framing and decking adjacent to this area. Refer to the existing conditions plans and the following photos for more details on the location of the problem areas.

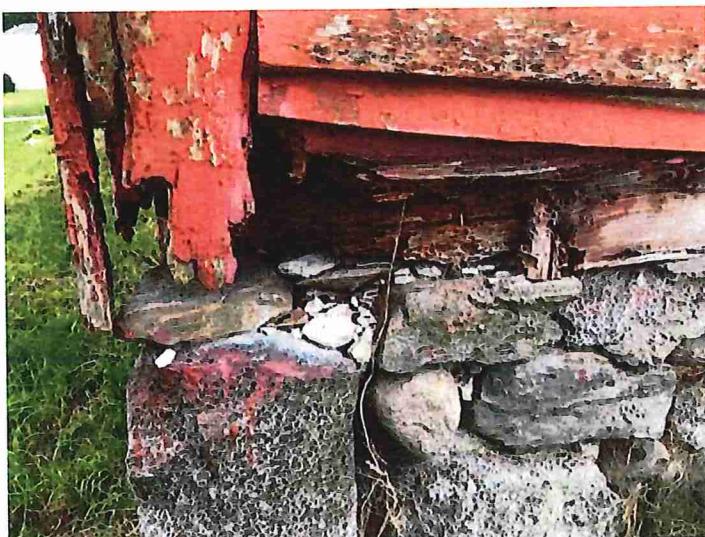
Evidence of a severely rotted sill along the south wall of the Storage Barn is evident, and wood props, set on the top of the stone foundation wall have been added beneath each of the floor joists along this wall. The rotted sill has been removed, and a cast of the former sill is extant in the concrete that was added to the exterior to retain the soil at the planting beds within the former greenhouse structure in this area.

Figure 9 - Rotted sill, trim and clapboard at northeast corner of Storage Barn

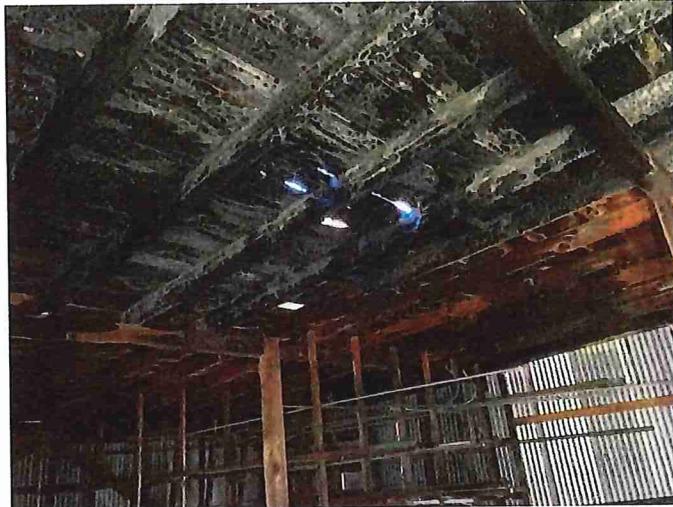
The membrane roofing over the Blacksmith Shop has blown off completely and the sky is visible between the charred wood roof sheathing boards in places, (figure 13) indicating that the older roofing is also missing in places.⁶ The charring has in many cases reduced the cross section of the wall and roof framing members by a significant amount, reducing the load carrying capabilities. The roof framing members are small for the span and spacings used in any case. Char can act as a wood preservative, but prolonged exposure to the elements will inevitably cause further damage to these already weakened structural elements.

Figure 13 - Charred wood roof framing and holes in roof at Blacksmith Shop

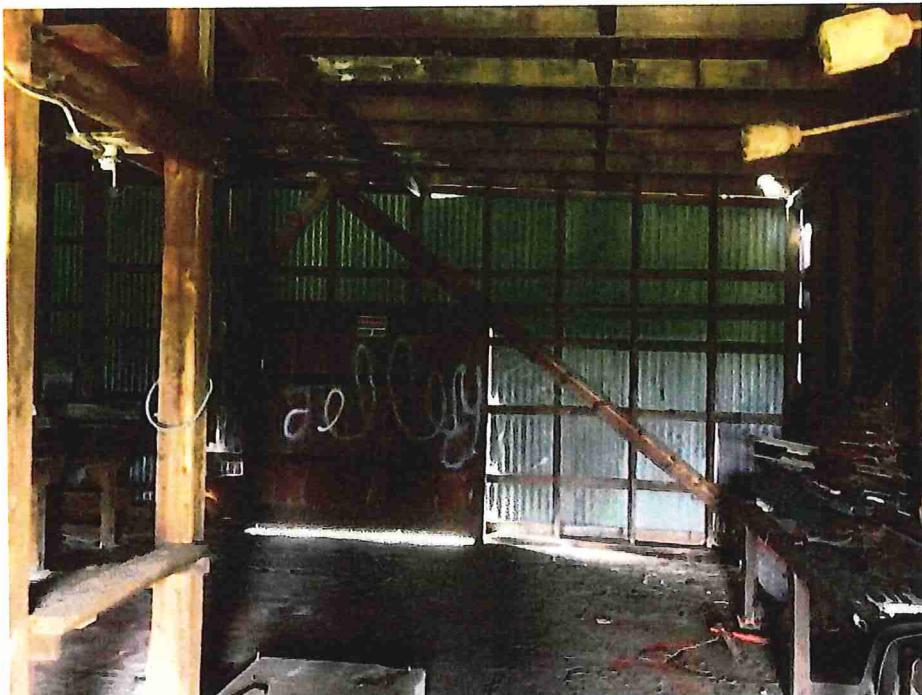
Figure 15 - Interior of Sawmill looking west, hole in roof allowing sunlight at top right

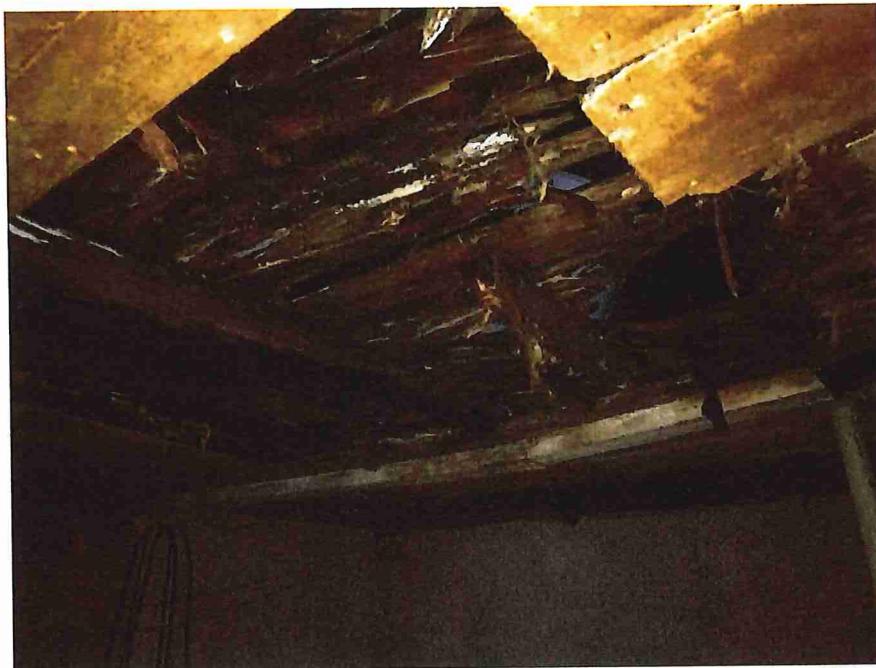
Figure 17 - Structural collapse over cold room. Note mid-span stop-blade scarf joint (splice) in beam (painted white), which is in failure

An additional section of the tongue & groove board finish between the two (east-west) beam lines was neatly removed, presumably to inspect for further damage or rot. The framing visible in this area appears sound and dry. The framing is 2" x 6" (actual) at 24-inches on centers and spans from the south exterior wall to the concrete foundation wall at the north, supported at approximate third points by two lines of 6 x 6 wood beams set on wood and steel posts. The 6 x 6 wood beams are spliced, mid-span in a number of locations using stop-blade scarf joints, (see figure 18) which is a robust splice connection, but they should sit directly over a support point. Note that it is unknown if the splice joints in these beams are pegged or lagged from above, as shown in figure 18. One of these splice joints has failed, refer to figure 17, above.

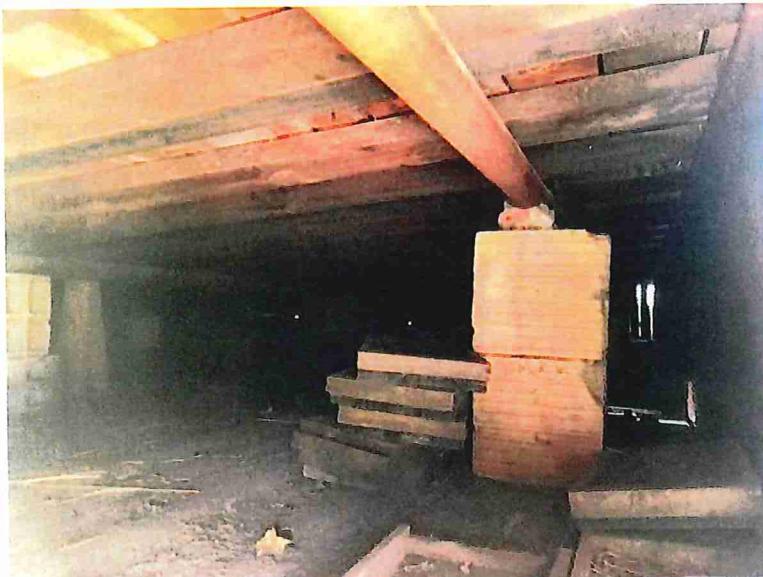
pipe purlins are 2x or 3x dimensional lumber, of varying widths, *on the flat*, acting as rafters, clad with wood boards. It is assumed that the wood boards are nailed to the flat rafters, no other attachment between the roof diaphragm and the structure below is evident. It is assumed that the dry-stacked masonry piers sit over the two beam lines below. Inadequate resistance to wind uplift and the lack of bracing of the stacked masonry are significant issues with this roof structure. That said, the portions of the roof structure and what appear to be original floorboards visible from this single vantage point do not show signs of sustained water infiltration or evident failure. A number of openings in the surrounding sheathing/siding system were evident and are visible in figure 19, below, allowing for infiltration of the elements and vermin.

Figure 19 - Space under 'temporary' roof at the Workshop Complex

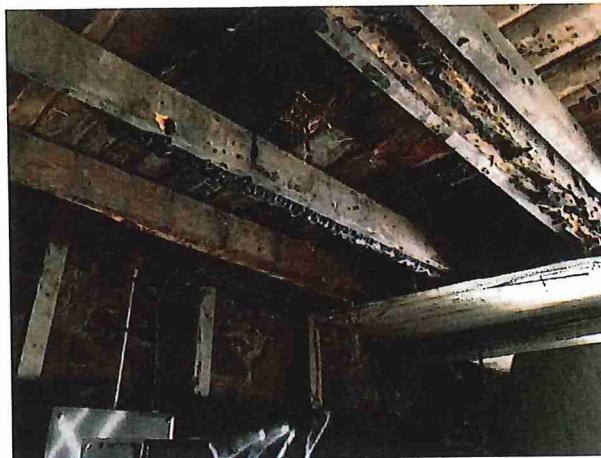
Figure 20 - Eastern sistered framing at Cellar showing rot, fire, and insect damage

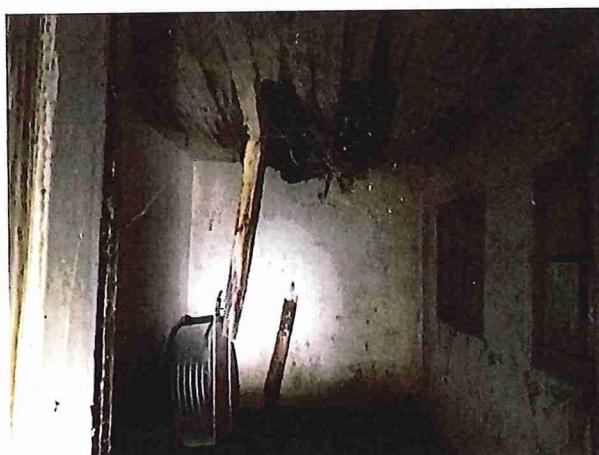
Figure 21 - Collapsed ceiling in small cooler (below Sawmill raised framing)

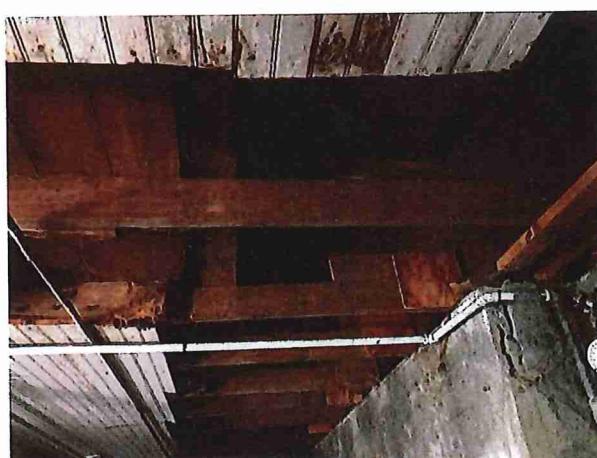
Figure 22 - Northern sistered framing, props and gussets, showing rot and insect damage

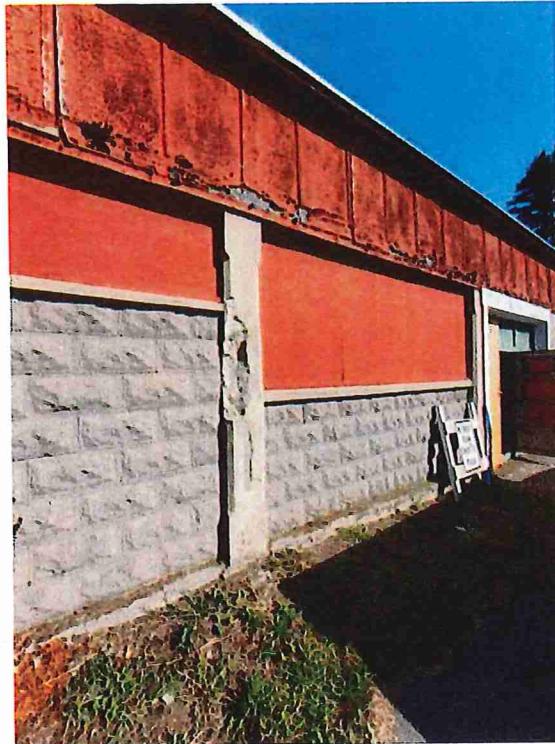
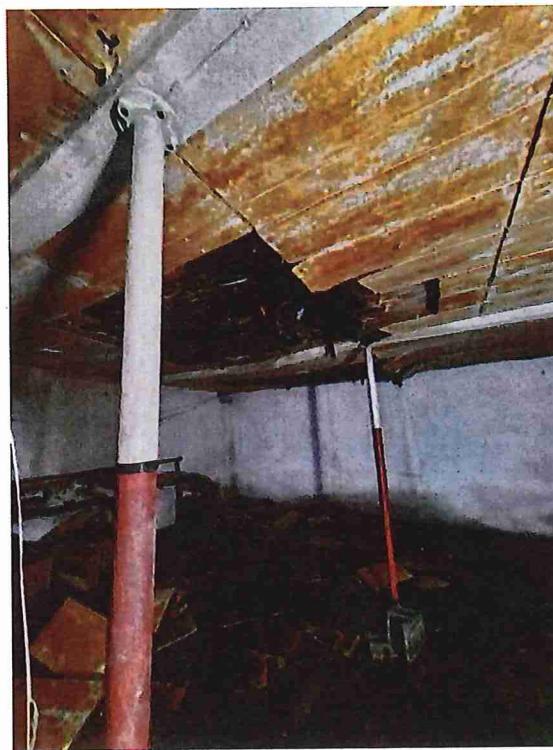
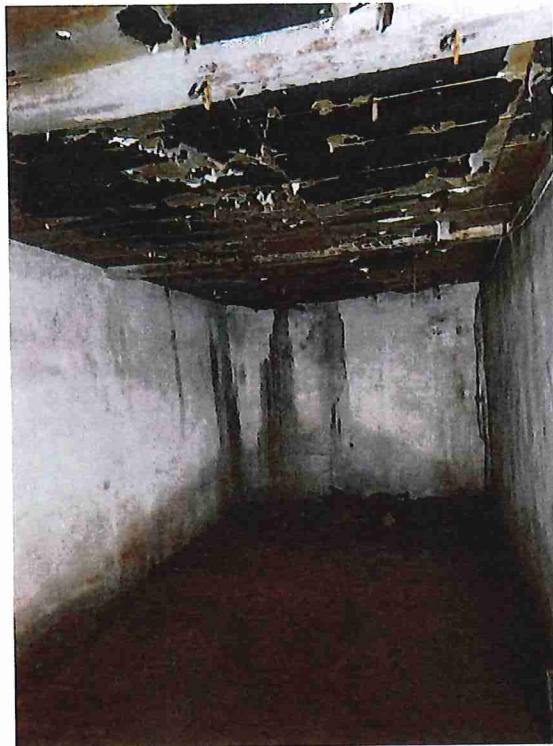
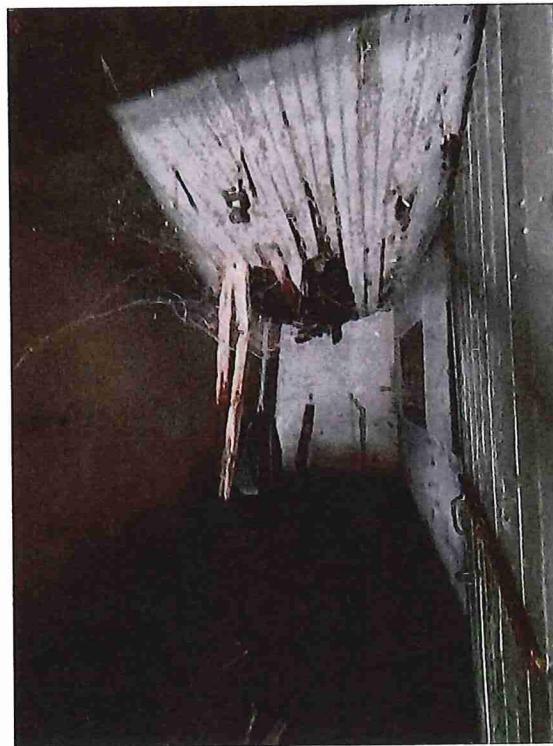
We entered the Garage/Workshop/Cooler building first where we noted standing water on the slab-on-grade. The Cold Room and both cooler rooms have significant water damage and rot which has led to partial collapse of the structure in these locations. See Photos 2, 3 & 4. The wood framing in the coolers and the cold room will need to be fully replaced due to the extent of the rot. Additional sections of the roof framing will need to be exposed and possibly replaced.

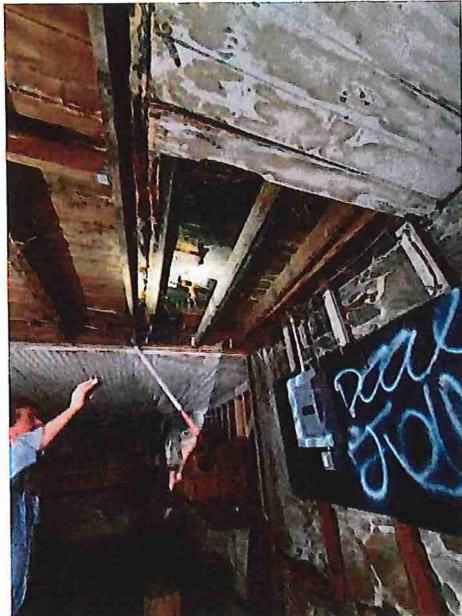
Photo 5.

In the main garage portion of the building there is an area with fire damage (see Photo 5) and insect damage could be seen in the exposed ceiling along the back wall of the structure. See Photo 6. The roof above the garage is composed of sloping 2x members which are supported on either end of the building and at the center of the building with a stacked wood or brick. This roof system is not sufficient or safe and would need to be fully replaced possibly with new wood truss system. The drainage on the roof would also need to be redesigned.

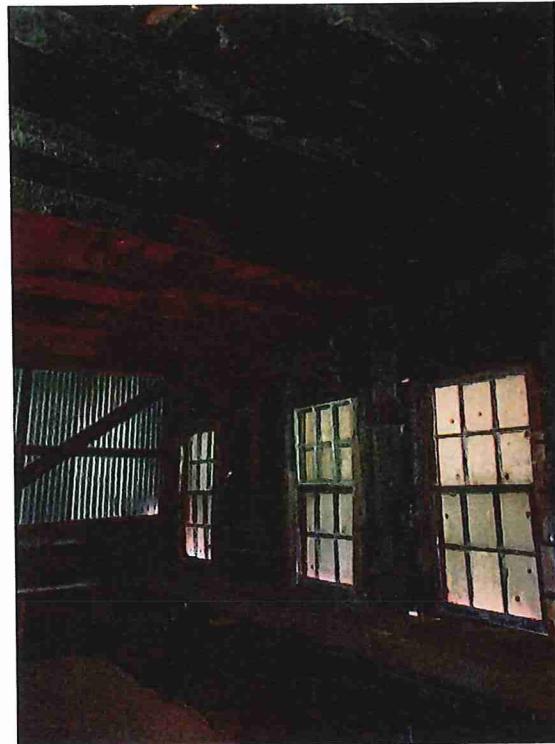
The interior of the building has sustained fire damage along both wood framed walls and parts of the ceiling. See Photo 10. The main room is located above the cooler and cold room from the garage below where the partial structural collapses noted previously in the report. The floor is not stable enough to support a person therefor all observations were made from the main entrance door. Wood 6x6 beams (assumed) run the width of the building which support the roof joists. See Photo 11. The beams are under sized and are not sufficiently supported at the corrugated metal wall.

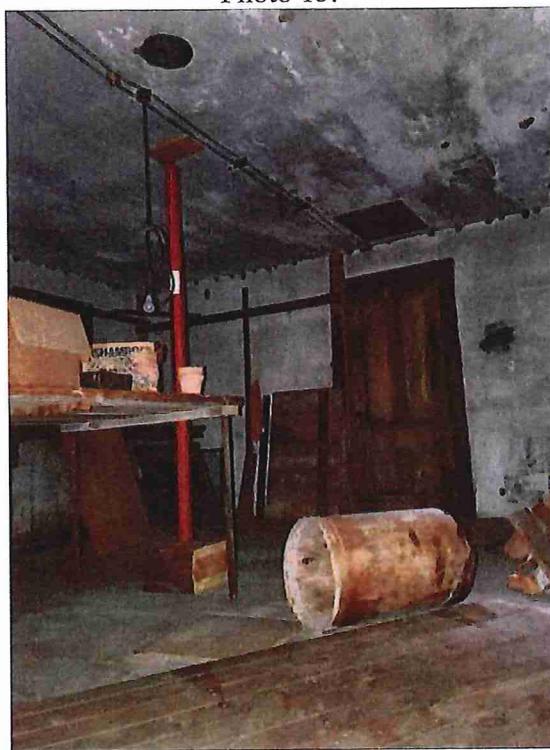
The interior of the original corn crib room has been plastered over. The ceiling appears to be sagging in the center and supported by a temporary steel column. This room was designed with all exterior walls sloping inward at the base. See Photo 16.
