Justus Richardson Homestead (Richardson House)

Conditions Assessment: Beaver Brook Farm, 761 Mammoth Road, Dracut, Massachusetts

<u>BUILDING NAME:</u>	Stone Garage
<u>DATE(S):</u>	1870-90 (?); ca. 1920-30 (?)
<u>SIZE:</u>	13' x 47' approximately 600 square feet on one level below grade
<u>TYPE OF CONSTRUCTION:</u>	rubble masonry (ca. 1870-90) lined with poured concrete walls & floor (ca. 1920-30)
<u>HISTORY:</u>

<u>BUILDING NAME:</u>	Workshop Complex
<u>DATE(S):</u>	ca. 1870-90; ca. 1900-30; 1942; 1972
<u>SIZE:</u>	East Section – 29' x 35' Central Section – 77' x 29' West Section – 24' x 44' approximately 1,000 square feet at the first floor of the East Section and 1,050 square feet at the first floor of the West Section; approximately 2,250 square feet at ground level in the Central Section
<u>TYPE OF CONSTRUCTION:</u>	mixed wood frame, rubble foundations (southeast & southwest corners), poured concrete elsewhere East Section: poured concrete foundation with wood-frame structure above Central Section: rubble stone foundation at east end, concrete piers & concrete block infill; poured concrete at rear walls West Section: rubble stone foundation (south & west) & concrete (north)

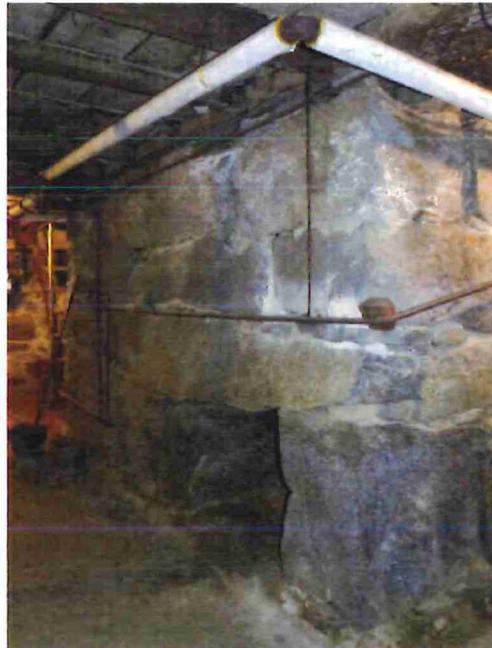
Figure 2 - granite base of central chimney & unexplained opening on west face

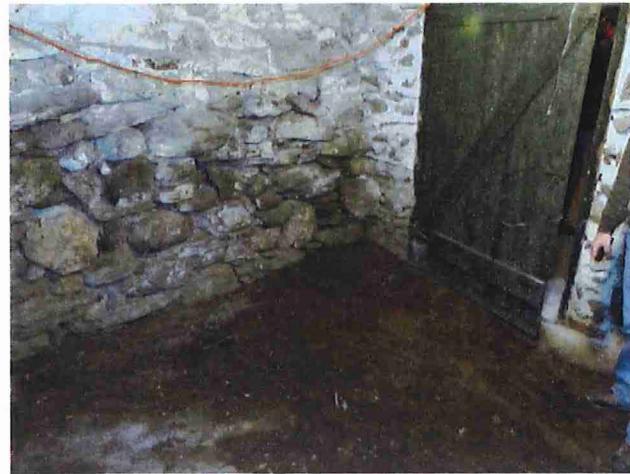
Mortar joints along the east end of the cellar's south wall are extensively eroded, and a small delta of silt has built up on the floor due to rainwater run-off from the roof that drops next to the foundation and seeps into the cellar. Stones were probably laid dry with point-to-point contact during construction, but eliminating rainwater run-off in the cellar and re-packing eroded joints is desirable to protect the stability of the wall and seal the cellar. All surfaces bear evidence of

Figure 3 - south wall of main house foundation showing washed-out mortar joints & silt

- Clear shrubbery away from south elevation and re-grade southeast corner to provide positive drainage away from structure.
- Inspect water damage & sources at southwest corner of ell; repair at least temporarily to reduce structural damage.

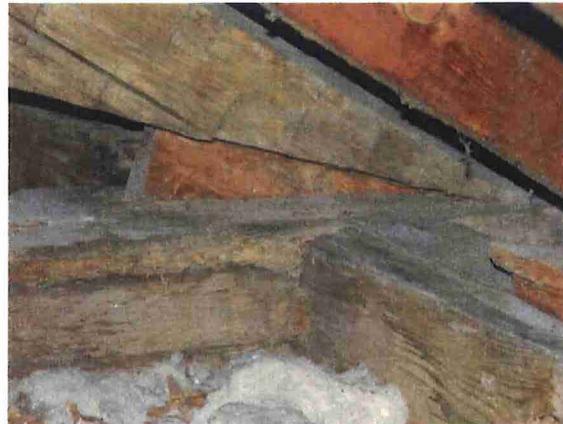
Figure 4 - north end of rafter at main house showing exposed tenon

- o Inspect attachment of rafters to plate at rear roof of main house
- o Inspect roof framing at north end of ell (east & west slopes) where bowing visible
- o Repair and re-point central chimney above roof, install new lead flashings; install top-mounted dampers, ventilated caps or shelf over top of chimney to reduce rainwater in flues
- o Repair and re-point rear chimney above the roof, install new lead flashings; permanently cap with vented cap.
- o Re-point front stoop & re-set loose bricks
- o Evaluate condition of roof-coverings & confirm that they are asbestos cement; consider treatment with preservative as originally specified by manufacturers to prolong usable life
- o Re-fasten loose clapboards and trimmings, repair balustrade at main entry portico, prepare surfaces and re-paint.
- o Repair existing sash & storm windows, prepare surfaces, re-putty as needed and re-paint.

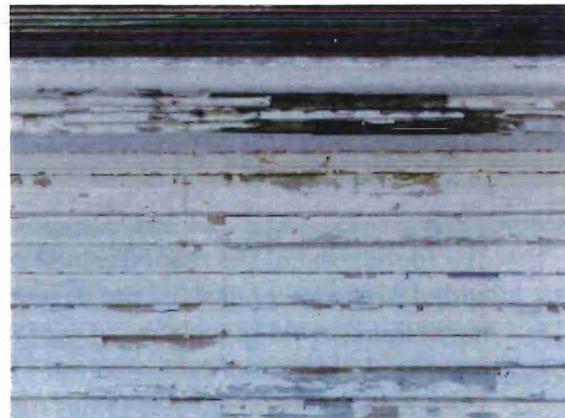
- **Gutters & Drainage:** Eaves are fitted with wooden gutters, none of which function correctly. At the façade of the main house, gutter ends have been removed and downspouts are disconnected with the result that rainwater run-off is concentrated at the south foundation where it is eroding mortar joints and flowing into the cellar. The north gutter has a single downspout toward its center. This drains some water but appears to overflow during heavy rain. The gutters on the rear ell are made up of patched sections of wooden gutter with downspouts that drop near the north end of the ell and direct water into the cellar. Gutters on the west side of the ell near its south end have failed and water is entering the wall cavity and interior.

Figure 5 - west elevation of rear ell - failed gutter

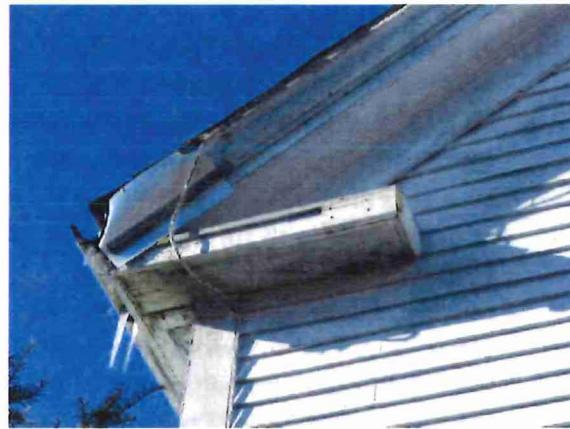
Figure 6 - main house - southeast corner with open gutter end & missing downspout

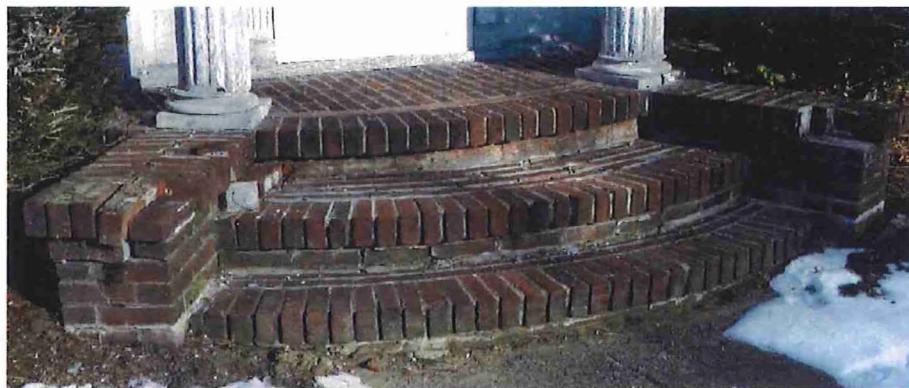
Figure 7 - damaged brickwork at front entry

- Either re-set loose bricks from main entry portico or gather and store detached bricks for future installation.
- Install a temporary vented cap on the chimney of the rear ell to dry the flue.

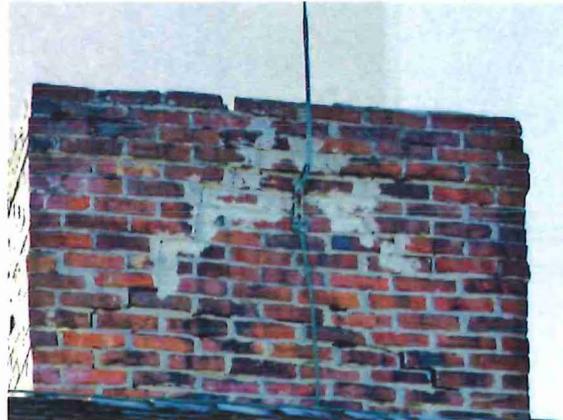
- o The central chimney of the main house is a massive structure that rises from a base of quarried granite blocks which may serve as retaining walls to hold unexcavated earth on which the chimney was originally constructed. The west wall of the chimney's base in the cellar contains an unusual recessed opening that is roughly shaped like a firebox and has a flue-like opening that rises above it to the base of the first storey where it has been blocked. The origin and purpose of this opening are unknown. At the first floor, the chimney has two fireboxes on its east and west faces, both of which have been rebuilt in the early twentieth century, perhaps reducing the size of original openings that remain behind modern masonry finishes. At the rear (north) of the chimney in the position that would typically contain a cooking hearth, a built-in sideboard prevents access. It is not known whether the cooking fireplace remains in position or has been removed. At the second storey, the chimney has two fireplaces (east and west) of which the east fireplace preserves its pre-1850 firebox and mantel. Above the roofline, the chimney has several cracks and open joints on its north face.

Figure 9 - north elevation of central chimney showing cracks & patches

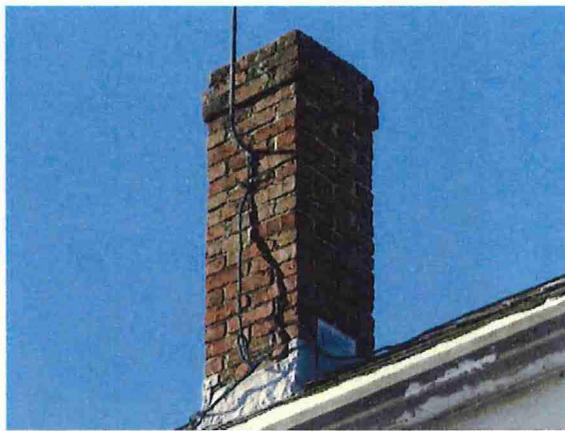
- The rear ell's chimney possesses a single flue constructed for a kitchen stove. The chimney rises from the cellar to the roof in a single straight stack. All sections of this chimney exhibit excessive moisture in the bricks and mortar. The source of moisture is the open flue and lack of burning on the flue which would have served to keep it dry as long as a stove was connected to it.

Figure 10 - east & north faces of chimney at rear ell

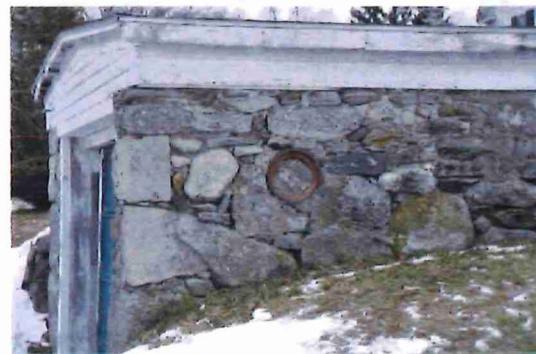
Figure 1 - north wall showing blocked terracotta pipe

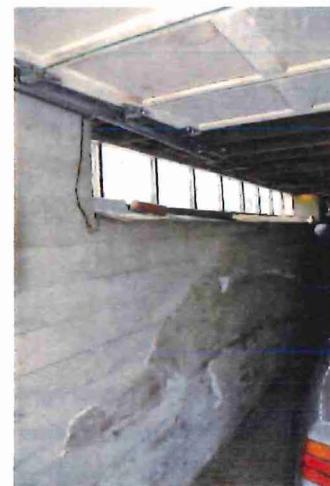
Figure 2 – south wall showing salt stains on concrete

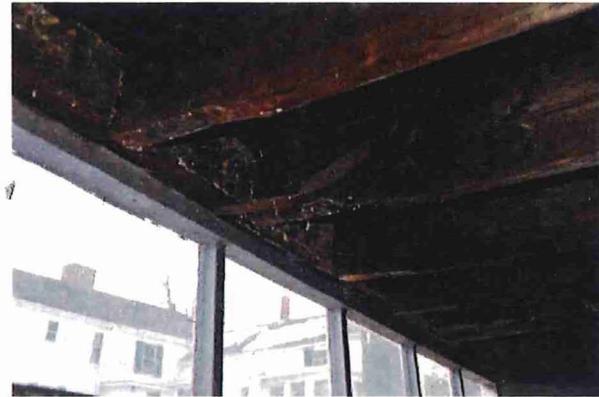
Figure 3 - roof framing showing possible frass caught in cobwebs

- cyclical inspection of mortar joints at rubble foundation,
 - cyclical inspection of interior for presence of wood-eating insects.
 - Maintain perimeter of building free of brush, weeds and trees.

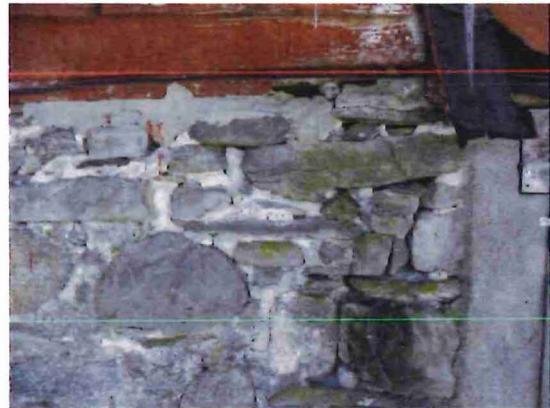
- **Rubble Stone foundations:** The end sections of the foundation appear in sound condition excepting cracks at the east end of the south elevation and near the mid-point of the east elevation.

Figure 4 - crack near mid-point of east elevation

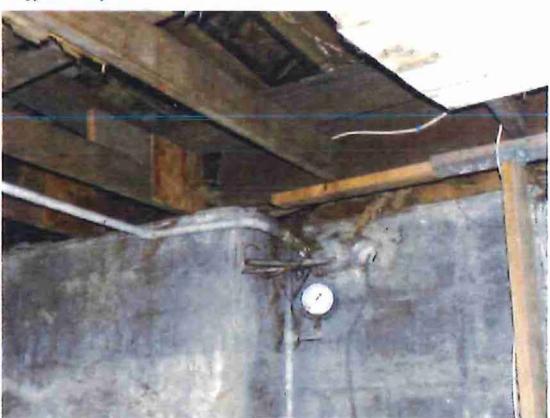
Figure 6 - north wall of cellar showing decayed joists & gussets & added post (photo right)

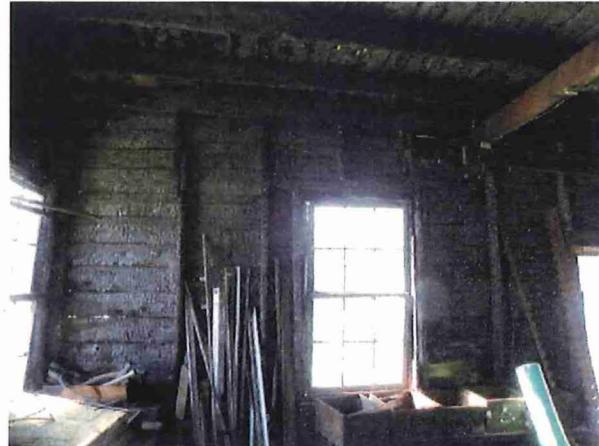
Figure 8 - southwest corner - charred framing

many cracks open to the weather; prolonged roof leaks raise questions about the strength of remaining charred timbers.

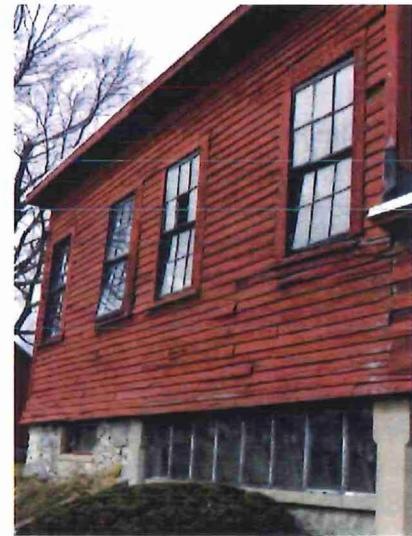
Figure 9 - south elevation showing loose windows & deteriorated siding

- **Urgent (1-2 years)**
 - o Conduct additional historical research (primarily oral history research) to determine the use of the Workshop Complex, the historical value or equipment that remains in the space and the Complex's importance to the history of Beaver Brook Farm in order to make historically reasoned decisions about the repair, reconstruction or removal of this group of buildings.
 - o Re-cover the East and West Sections with rolled roof or other inexpensive roofing to stop leaks; framing in both locations may already be compromised by the combination of fire damage to some timbers and rot.
 - o Re-set all loose windows and either re-glaze or provide temporary blocking for missing panes.

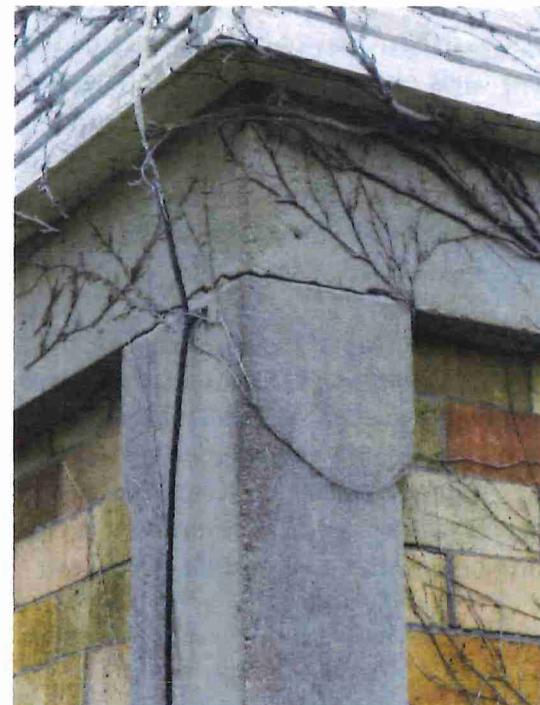
- **Concrete structure:** The foundation appears sound as do the bases of all piers; however, every pier has a horizontal crack extending across the full dimension of its head at the base of the concrete lintel. These cracks align with the bottom flanges of steel "I" beams that run north-south between the outside walls. These beams are cased with concrete that bevels outward from the top of their bottom flanges to the base of the poured concrete second storey. Fully exposed "I" beam run from east to west in staggered locations between the concrete-cased beams. Cracks at the head of exterior piers may be the result of rust expansion at the bottom flanges or merely of two separate pours of concrete that are inadequately bonded. It is unknown what (if any) re-inforcement materials may anchor the "I" beams to the

Figure 1 - typical crack at head of pier - northeast corner

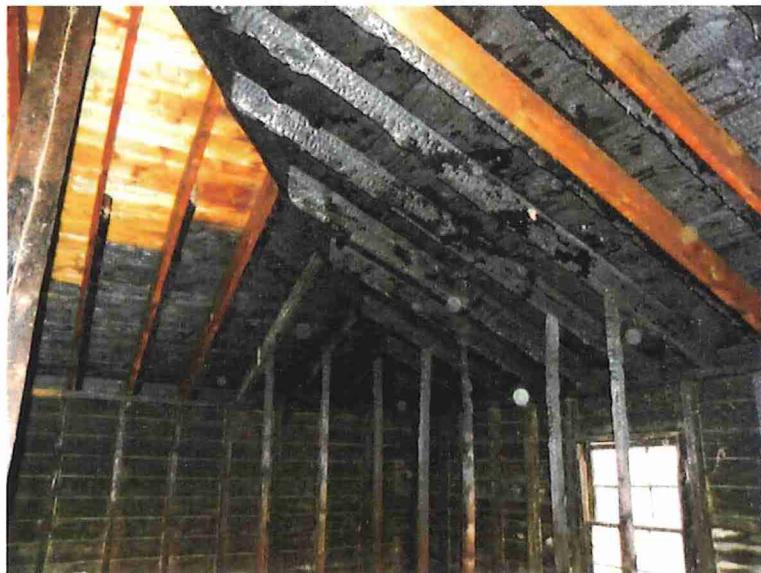
Figure 3 - southeast corner - fire damage from 1942

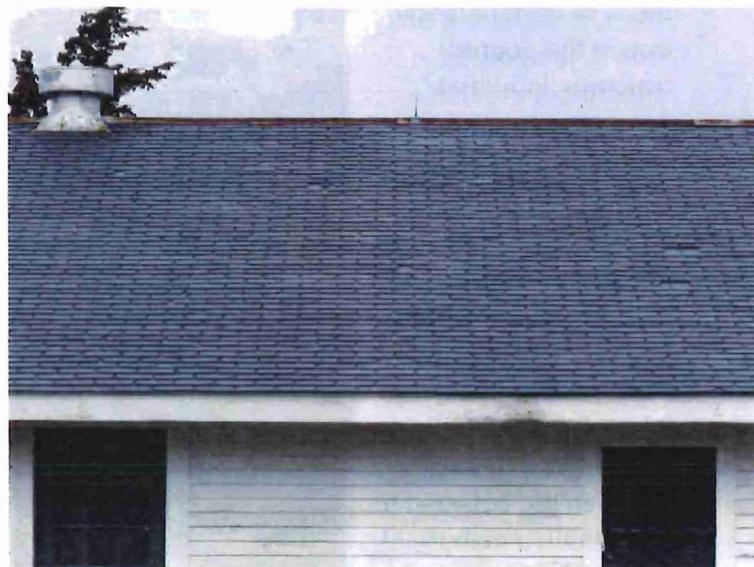
- **Roof:** The structure is enclosed by a hip roof covered entirely with slate that appears to be in excellent condition with the exception of a small number (3% - 34 slates out of a sample of 1,232 counted) of missing, slipped or chipped slates, many of which may remain functionally sound despite a chipped corner or crack. The ridge of the roof is penetrated by three galvanized iron ventilators that are partially rusted.

Figure 4 - roof showing typical condition of slate in area sampled

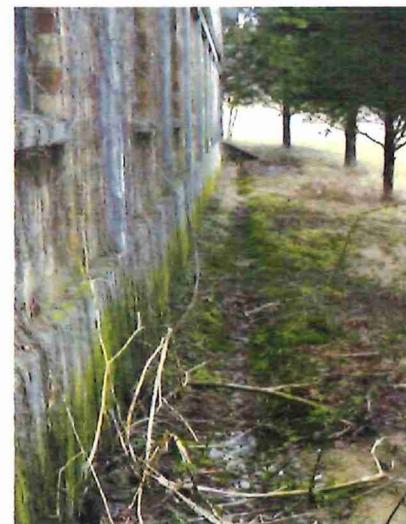
Figure 5 - trench at north elevation – from rainwater run-off

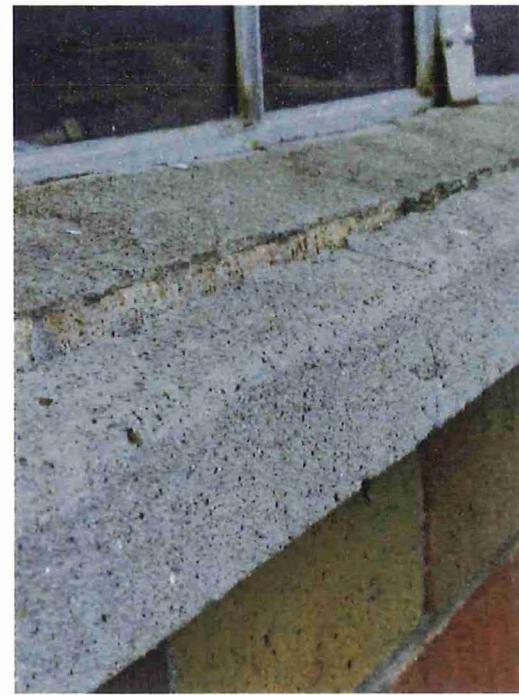
- **Windows:** The ground floor is fitted with steel-frame industrial windows set between iron mullions bedded into the terracotta walls. All windows exhibit rust from lack of

Figure 6 - south elevation - typical detached window sill & rusting mullion (background)

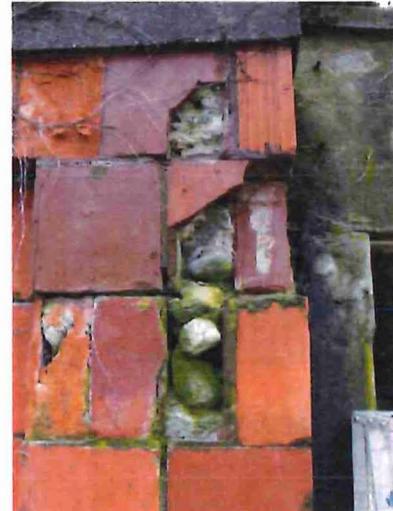
Figure 3 - rubble infill at northeast corner

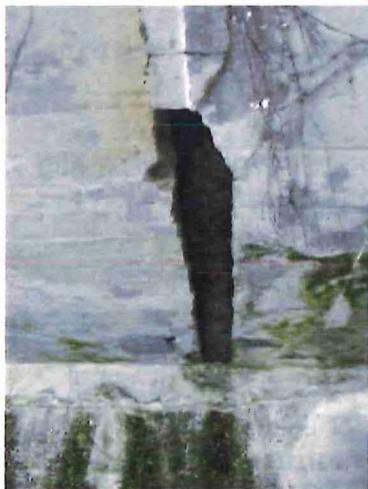
Figure 2 - corroding iron beam at ceiling

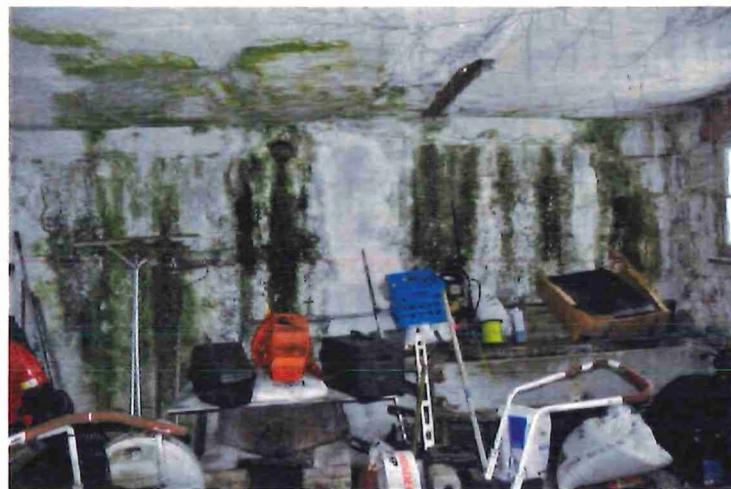
Figure 1 - algae, mold & vines at north wall

- Remove vines and weeds from the structure taking care not to pull roots that may have grown deeply into mortar joints and terracotta blocks; cut roots instead. Cut all trees from the roof but do not pull the roots until the extent of their penetration into the structure has been determined.

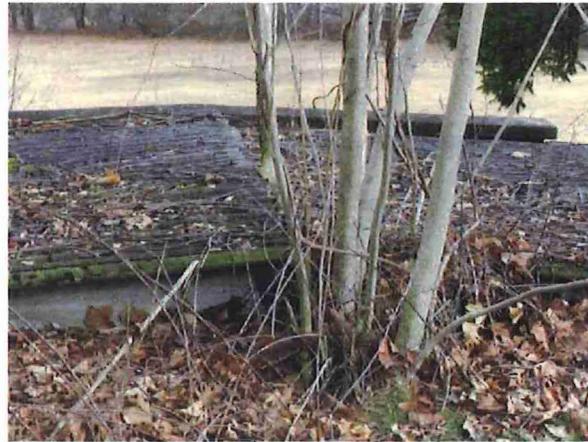
Figure 4 - trees growing through roof of corrugated cement asbestos

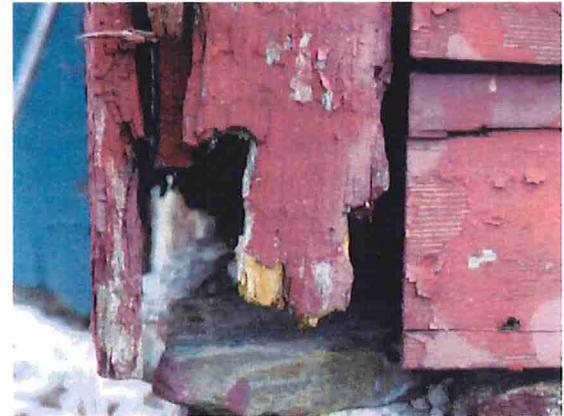
Figure 7 - deteriorated northeast corner post

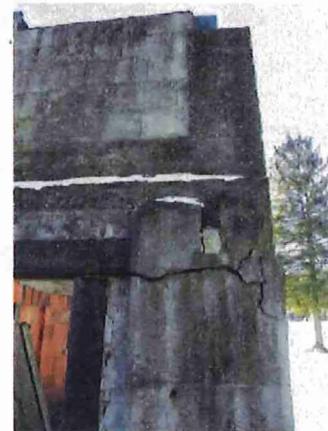
Figure 1 - typical cracked concrete at pier at Main Barn cellar

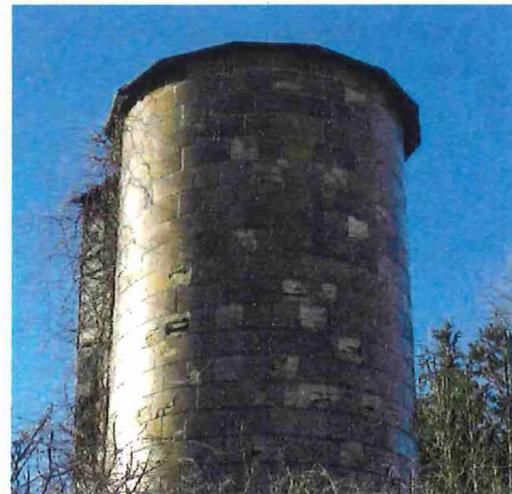
Figure 2 - west elevation of silo showing fractured terracotta

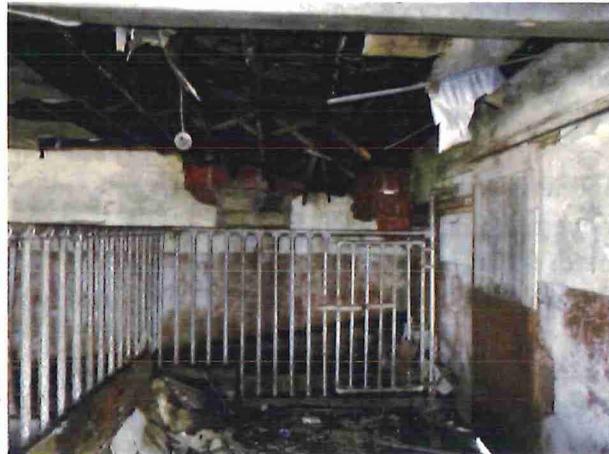
Figure 3 - northwest corner - collapsed joists

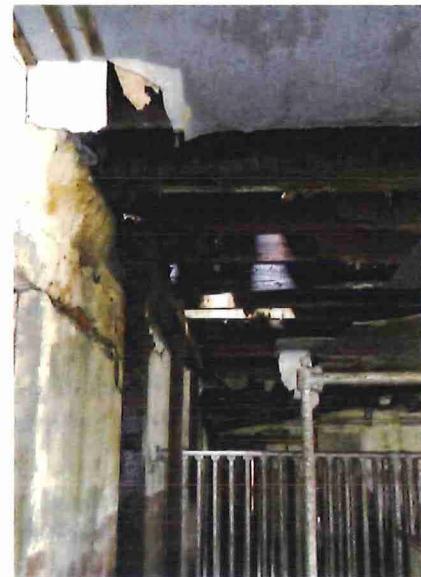
Figure 4 - collapsing joists at west wall
