TOWN OF DRACUT Beaver Brook Farm

**Existing Conditions Report -
Two Outbuildings**

September 30, 2021

Existing Conditions Report
TWO EXISTING BARNS
Beaver Brook Farm
Dracut, MA

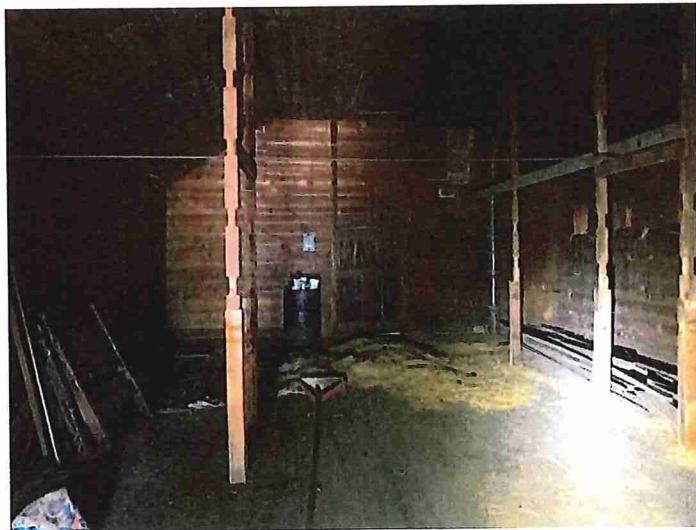
The wall and roof framing are clad inside with wood boards, so the framing is not visible, however the wood cladding follows the roof pitch approximately halfway up the slope, and then runs horizontally down the center, so attachment to collar ties is the natural conclusion. The collar ties are higher in the slope than we would recommend today, which may account for the sagging of the ridge visible from the exterior. There are several wood posts set on the floor, up to the north and south lines where the sloped wood clad ceiling meets the flat ceiling, or where the collar ties meet the rafters. It is unknown if these are props or part of a former storage or organization system. There is a steel tie rod at the eave line, and the approximate center of the Storage Barn (figure 5.)

Figure 5 - Interior of Storage Barn

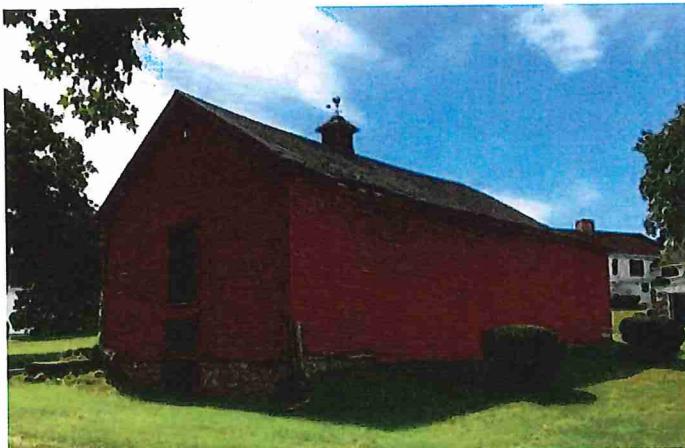
Figure 6 - Storage Barn

The asphalt shingles on the Storage Barn roof are generally in poor condition. The roof rafters are visible from the ground where the eaves and a portion of the roof decking have rotted away on the eastern end of the north wall. This opening in the roof has allowed water to penetrate the wall framing, down to the floor framing. Both the wall framing and the floor framing in this area have been compromised and may pose a danger. The Homasote/wood fiber panels attached to the ceiling in the basement, below this area are also collapsing and pose a danger.

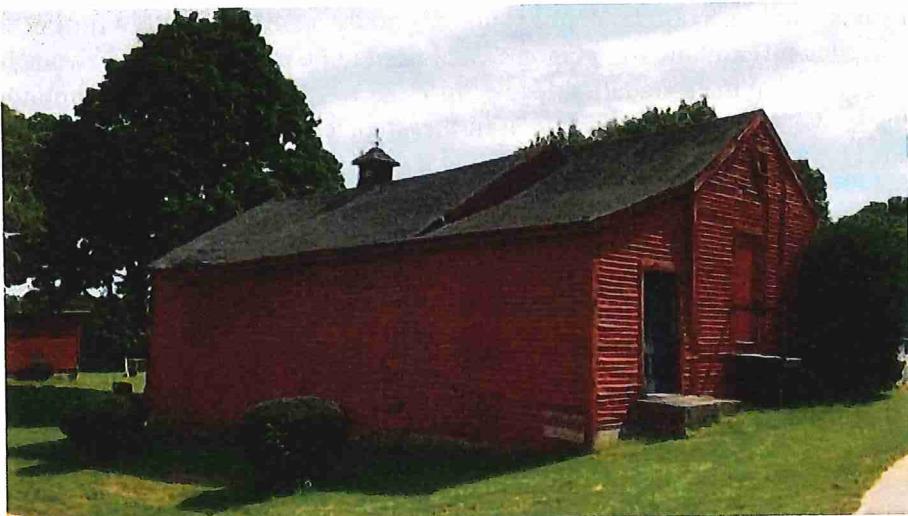
Figure 7 - Lean-to at center, Storage Barn (left) and Corn Crib (right)

The clapboard siding and trim is showing signs of wear, with some displaced, cracked and missing clapboard, similar to the rest of the Seedhouse structure as a whole. The asphalt shingle roofing is in fair condition. The concrete foundations, where visible appear to be in good condition, as is the concrete stoop.

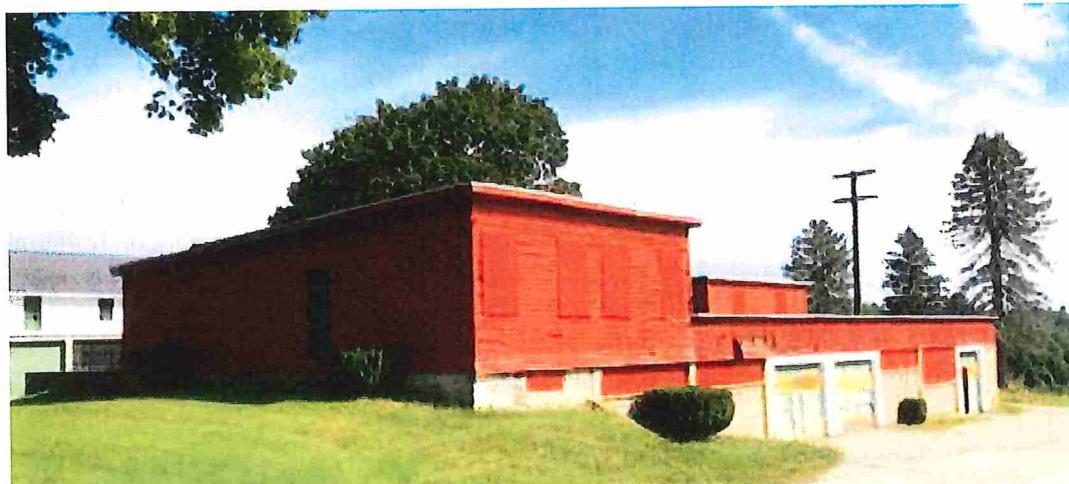
The Workshop Complex as it exists today can be broken into three main parts, each with its own entrance: The Blacksmith Shop at the west, the Sawmill at the northeast, and the Cellar in the center with a temporary roof structure over it. Fire damage, water infiltration, rot and insect damaged wood exist in all three sections of the building. There are a number of places within this structure where the floor framing has collapsed completely. Fire and water damage, and rotted wood have severely compromised other portions of the floor framing and some of the roof framing. Much of the framing reviewed by our structural engineer is undersized to begin with, and in its compromised condition it is unclear if the structure will survive the snow loads this winter, or a heavy windstorm, for example.

Figure 11 - Workshop Complex today, Blacksmith Shop at left (west) Cellar at right (east) and Sawmill visible above the temporary roof over the Cellar.

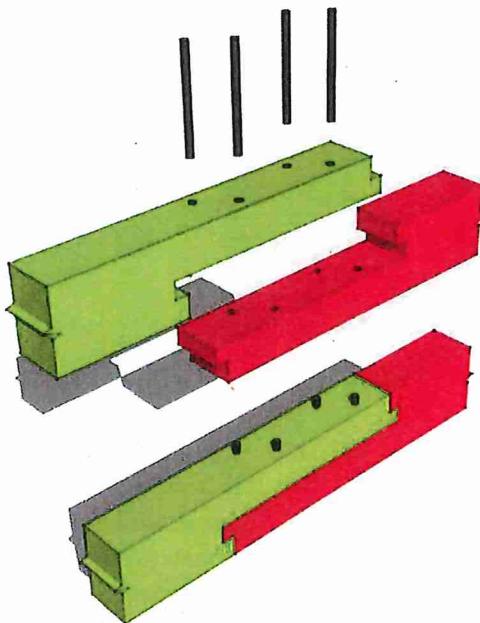
An additional section of the tongue & groove board finish between the two (east-west) beam lines was neatly removed, presumably to inspect for further damage or rot. The framing visible in this area appears sound and dry. The framing is 2" x 6" (actual) at 24-inches on centers and spans from the south exterior wall to the concrete foundation wall at the north, supported at approximate third points by two lines of 6 x 6 wood beams set on wood and steel posts. The 6 x 6 wood beams are spliced, mid-span in a number of locations using stop-blade scarf joints, (see figure 18) which is a robust splice connection, but they should sit directly over a support point. Note that it is unknown if the splice joints in these beams are pegged or lagged from above, as shown in figure 18. One of these splice joints has failed, refer to figure 17, above.

Figure 18 - Stop-bladed scarf timber frame joint, shown pegged⁸

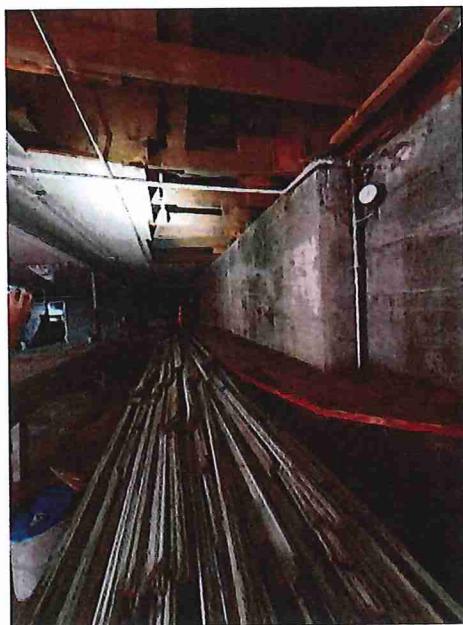
In the main garage portion of the building there is an area with fire damage (see Photo 5) and insect damage could be seen in the exposed ceiling along the back wall of the structure. See Photo 6. The roof above the garage is composed of sloping 2x members which are supported on either end of the building and at the center of the building with a stacked wood or brick. This roof system is not sufficient or safe and would need to be fully replaced possibly with new wood truss system. The drainage on the roof would also need to be redesigned.

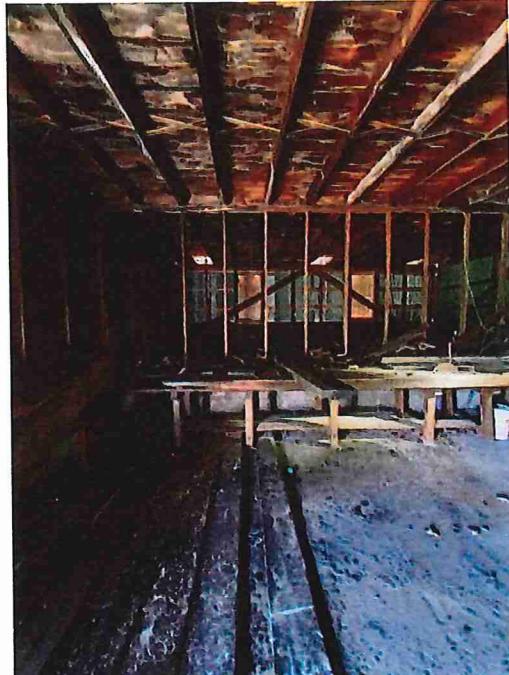
We then moved to the Saw Mill which is constructed with light wood framing. The Saw Mill work area is slab on grade while the wood storage area is located above the cooler room and the back side of the garage. Three of the four walls have metal sheeting and diagonal 2x6 wood bracing members to resist lateral forces while the last wall has wood board. See Photo 7. There is water damage throughout this room and a few holes were found in the roof which will need to be repaired. The existing roof beam shown in Photo 8 is under sized and will need to be replaced with a new LVL beam.

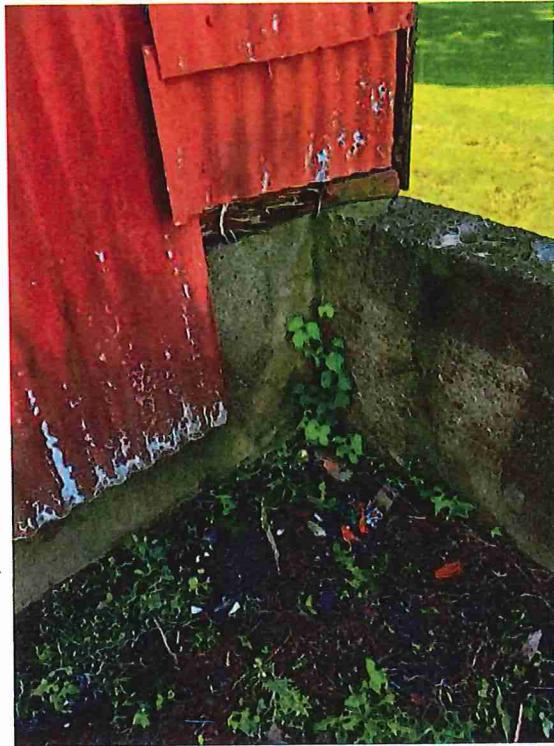
Photo 9.

The rubber roof of the Blacksmith shop has separated from the roof structure leaving it exposed to the weather. Insect damage and rot were found along the exposed areas at the foundation. See Photo 9 above. The exterior of the building is wood clapboard on two sides and corrugated metal siding on two sides.

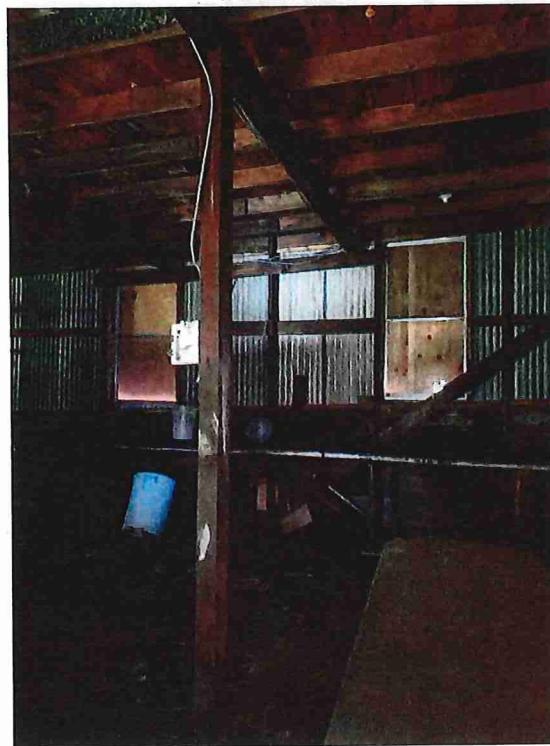
The interior of the building has sustained fire damage along both wood framed walls and parts of the ceiling. See Photo 10. The main room is located above the cooler and cold room from the garage below where the partial structural collapses noted previously in the report. The floor is not stable enough to support a person therefor all observations were made from the main entrance door. Wood 6x6 beams (assumed) run the width of the building which support the roof joists. See Photo 11. The beams are under sized and are not sufficiently supported at the corrugated metal wall.

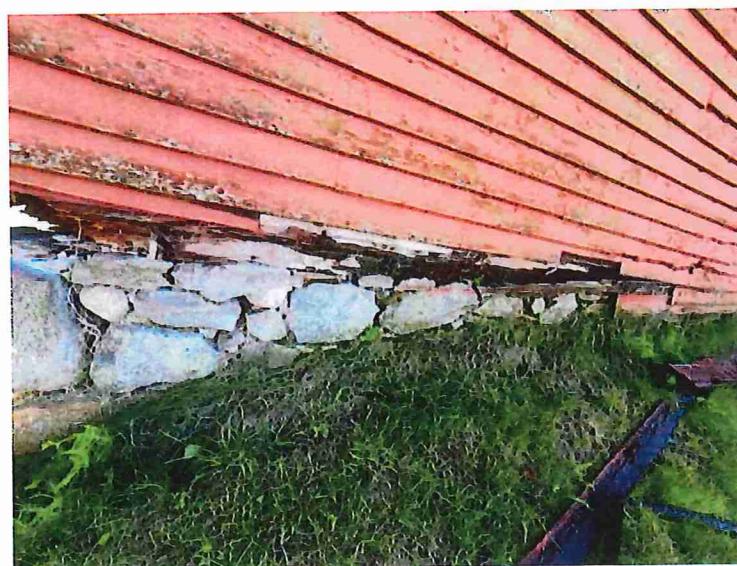
The Seedhouse appears to be an older balloon framed barn type structure. The exterior of the building shows rot and deterioration at the foundation line and portions of the roof have rotted away completely. See Photo 13. The exterior grade next to the building appears to go above the rubble foundation and comes in direct contact with the wood framing. This area would need to be carefully regraded to pull the soil level away from the wood framing while not exposing so much that would make the foundation wall unstable. Photo 14 shows the location of the previously demolish greenhouse. Further inspection of the wall studs on this face of the building would need to be preformed to determine if the prolonged exposure to the heat and moisture from the green house caused any significant damage.

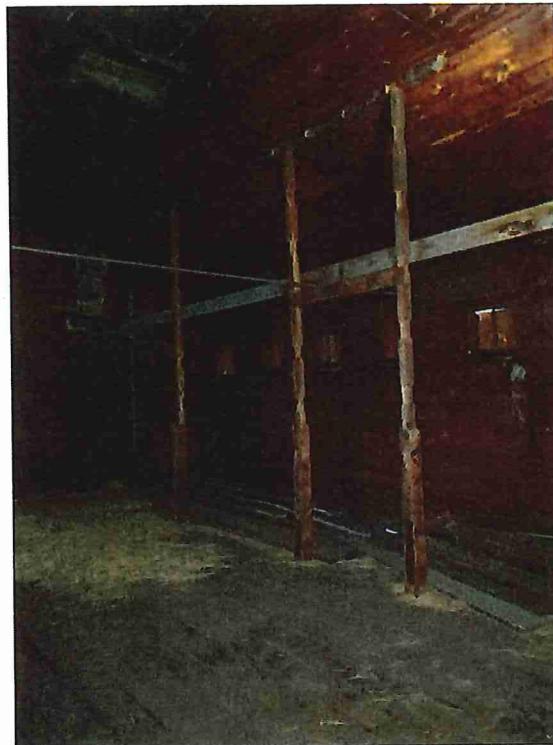
Photo 15.

The interior of the building is clad in wood planks making it impossible to assess the condition of the wall structure without selective demolition. It is unclear if the wood posts shown in Photo 15 below are structural but we believe they are part of a previously used rack storage system.
